# CASE STUDY : NOZZLES

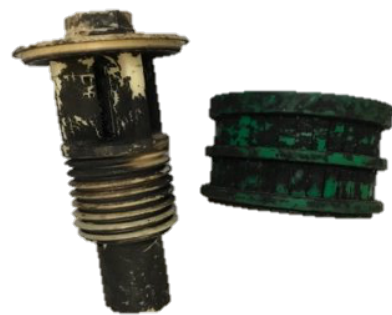
The team discovered that the nozzles in their filter bed were **choked up** by biofouling. They needed to remove this film but did not want to incur the **costs** and **inconvenience** of having to move all their media to do so. It also transpired that their supplier no longer manufactured the desired parts, so they would have to be custom made.

Rather than incurring significant environmental, monetary, and time costs by conducting a traditional refurbishment, Scottish Water came to Panton McLeod for an **innovative solution**. The company devised a method to inject PM77 at the correct level whilst keeping the media **in situ**. This was achieved by utilising lances and filling the plenum to the desired level in order to provide a foundation for the PM77 layer to sit upon. After the successful removal of biofouling, backwash cycles were returned to a steady state; resolving the issue of excessive media loss.
